To: sarah[sarah.jacobson@co.laplata.co.us]; Hakanson, Susan[susan.hakanson@co.laplata.co.us]; Knowlton, Butch[butch.knowlton@co.laplata.co.us]; Tommymoto McNamara [Personal Email/Ex. 6@gmail.com]; joe[joe.gabbard@co.laplata.co.us]; LPC Spina, Media[spinajm@co.laplata.co.us]; sean.smith@co.laplata.co.us]; frank[frank.sandoval@co.laplata.co.us]; Hitti, Media, SO[todd.hitti@co.laplata.co.us]; Downs, Media, SO[pat.downs@co.laplata.co.us]; jean.aldrich@state.co.us[jean.aldrich@state.co.us]; jeannine.natterman@state.co.us[jeannine.natterman@state.co.us]; Powell, Greg[Powell.Greg@epa.gov]; Smith, Paula[Smith.Paula@epa.gov]; Peterson, Cynthia[Peterson.Cynthia@epa.gov]; joe.lewandowski@state.co.us[joe.lewandowski@state.co.us]; jud@animasriverwetlands.com[jud@animasriverwetlands.com]
From: Dan Bender
Sent: Thur 8/13/2015 7:27:21 AM
Subject: Consolidated Ditch Test 8-12-15

Photos showing test on 8-12-15 of section of irrigation ditch owned by Consolidated Ditch Company, 12 miles north of Durango. Head gate was closed prior to main plume reaching the ditch. However, there was still some leakage since gate does not close water tight. Over approx 5 or 6 days, Animas River water ran passed head

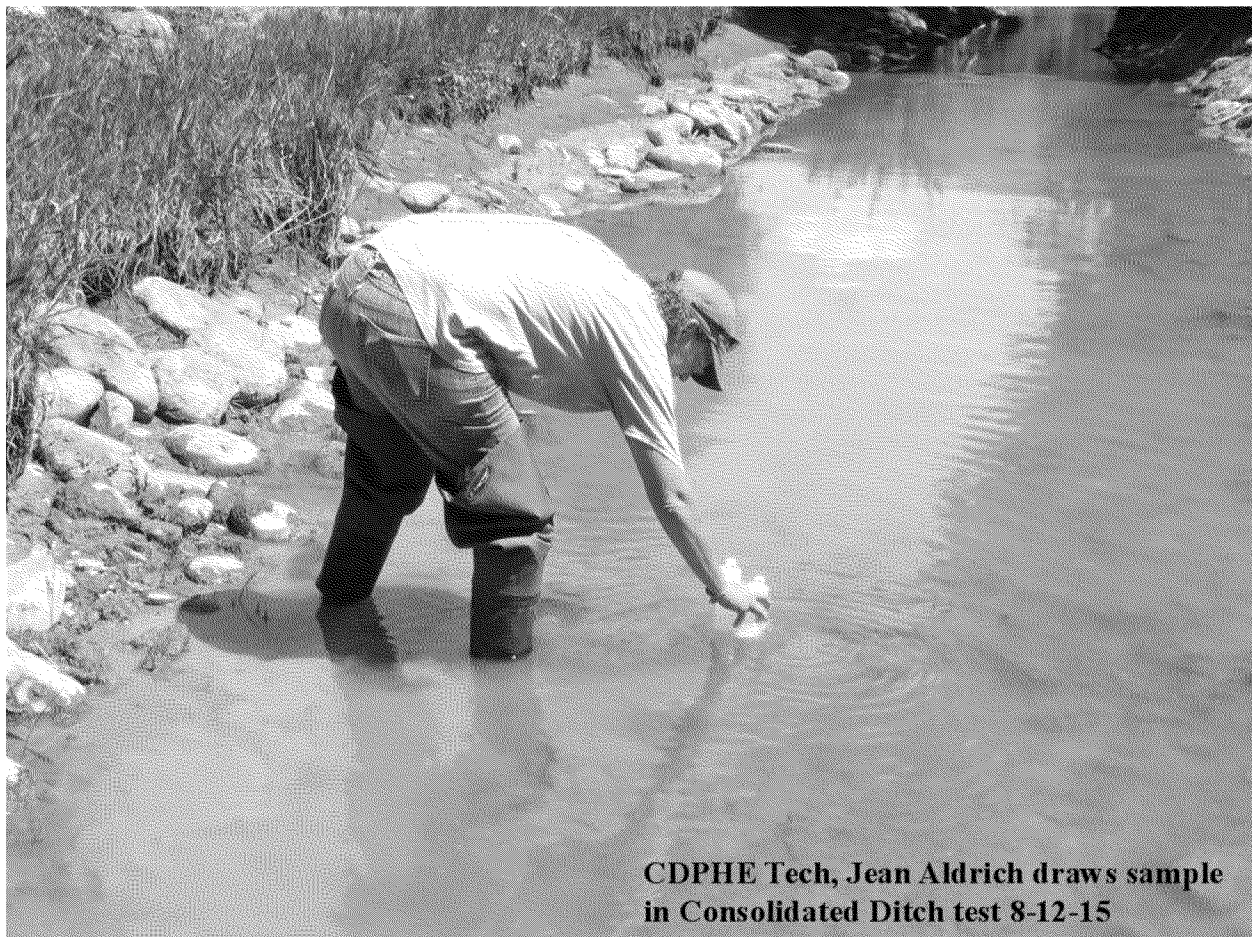
CDPHE Tech, Jean Aldrich draws sample
in Consolidated Ditch test 8-12-15

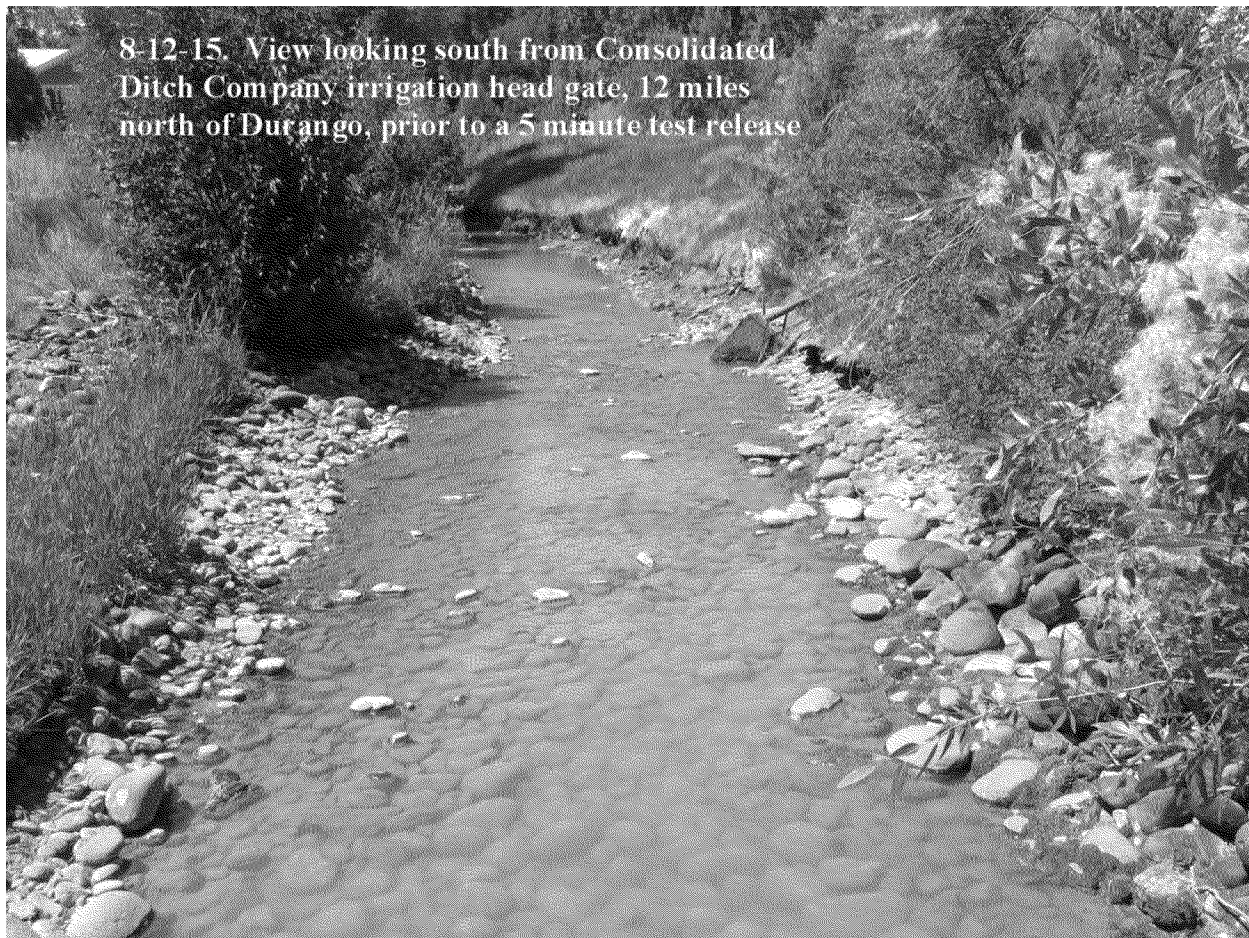
8-12-15. View looking south from Consolidated
Ditch Company irrigation head gate, 12 miles
north of Durango, prior to a 5 minute test release
